Sherlock Home Inspections

Property Inspection Report

6023 Evening View, Las Vegas NV, 89031
Inspection prepared for: Moriz Matsuzaki
Agent: Brian Lum - Elite Realty

Inspection Date: 9/9/2010 Time: 11:00 AM
Age: Built in 1996 Size: 1138 sq ft

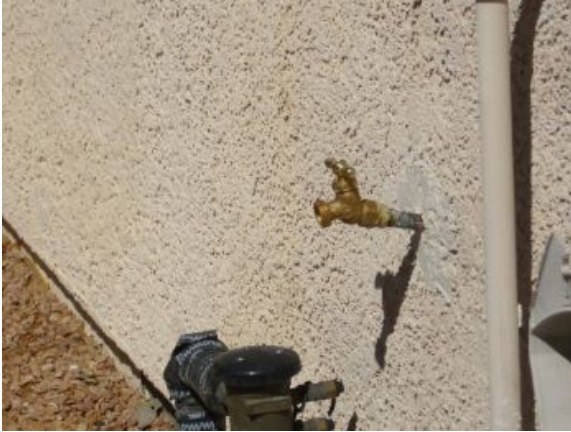
- Front and rear faucet are missing plural diverters. In need of repair.

Front and back faucet missing backflow diverter

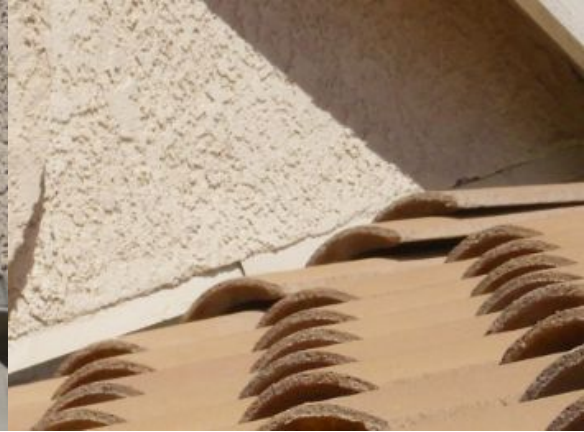
- Some roof tiles are loose at back of garage roof in front of house. Recommend repairs by a certified professional.

Loose tile on roof

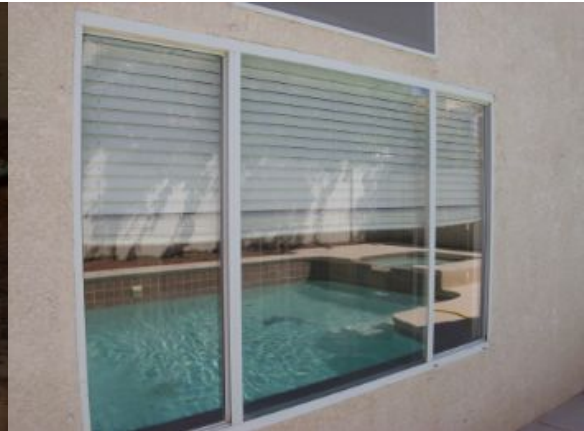
- Missing solar screen on rear window.

Missing solar screen

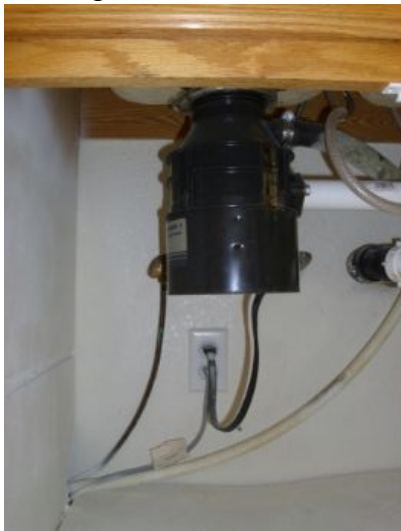
- Garbage disposal is jammed. In need of repair.

Garage disposal jammed

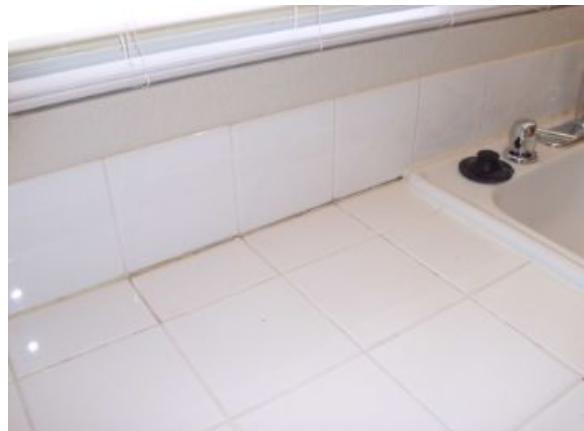
Crack in grout line

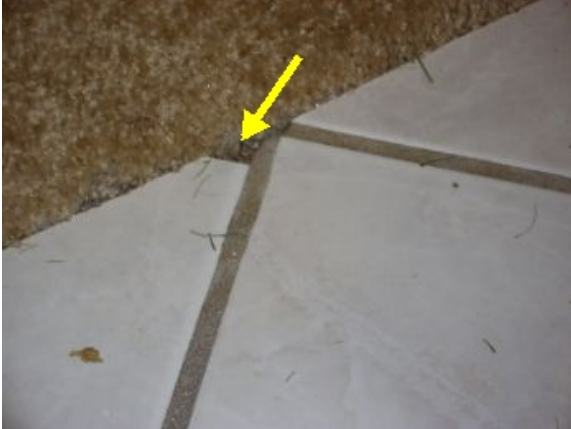
Observations:
 • Entry way at front door has corner chipped off of floor tile. No other problem noted. See photo.

End broken off of entry area floor tile

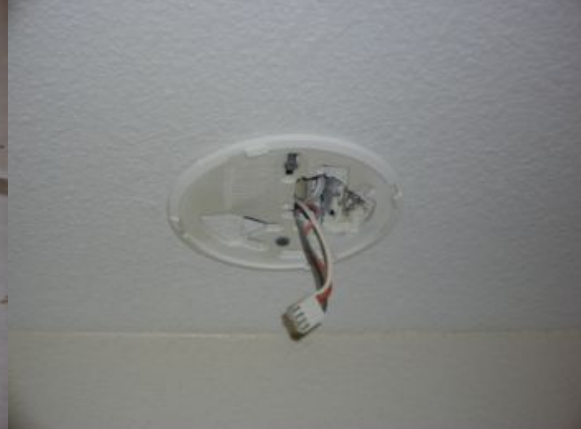
Observations:
 • Missing smoke detector. Recommend repair by certified professional.

Missing smoke detector

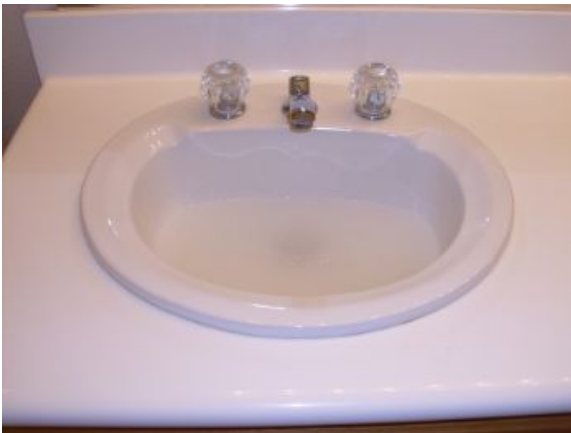
- All bathrooms sinks are draining slow.
- Hall bathroom sink stopper disconnected from stopper lever. In need of repair.

Slow drainage in all bathroom sinks

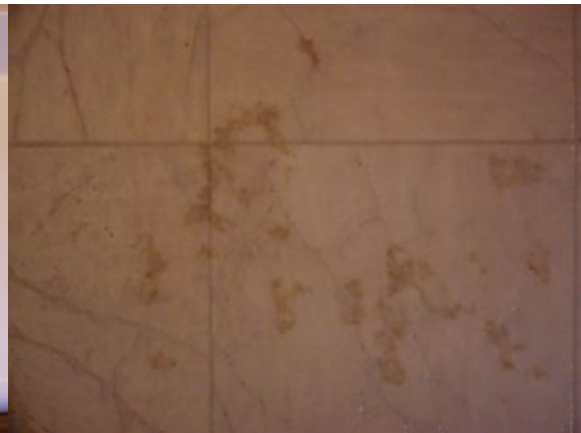
Materials: Vinyl Flooring.
Observations:
• Stains noted in hall bath on vinyl floor. See photo.

Stain on vinyl flooring in bath - cosmetic

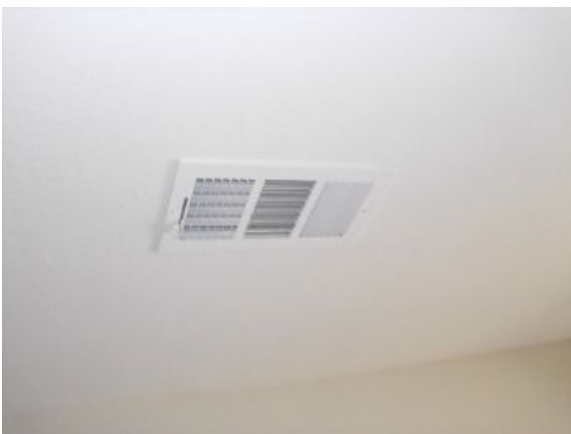
Observations:
 • Air flow from registers varies.

Air condition register

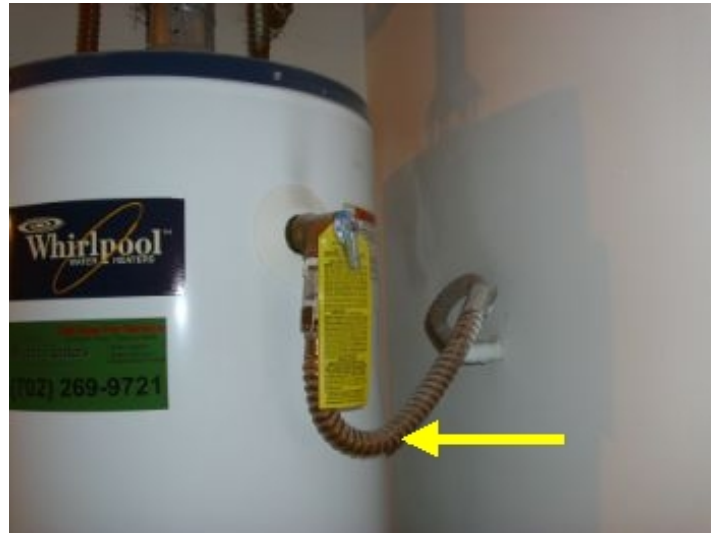
Observations:
 • TPR valve improperly installed. The drain line from this valve must not form a water trap.

TPR valve should not have water trap
